# Manhole Inspection Summary

Manhole # S51K\_\_013MH

Insp Date: **4/15/08 3:06 PM**

**Location** Address: **2825 fait ave**

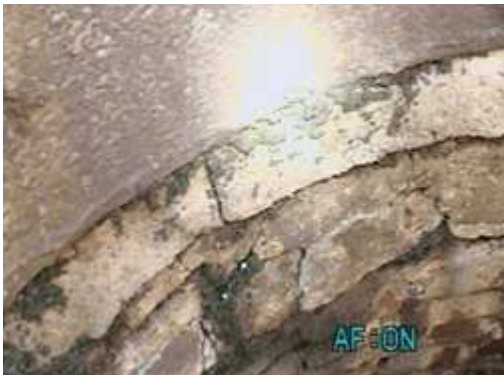
Defect 2

Condition: ☐ Sound ☒ **Cracked** ☐ Root Intrusion ☐ Loose Brick ☐ Deteriorated

crack in frame adjustment

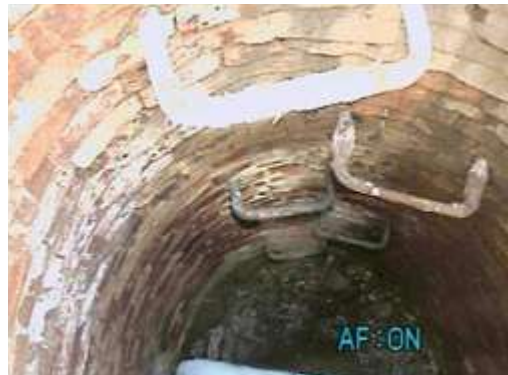
Defect 1

Count: **4** Missing: **0** ☒ **Corroded**

corroded stairs

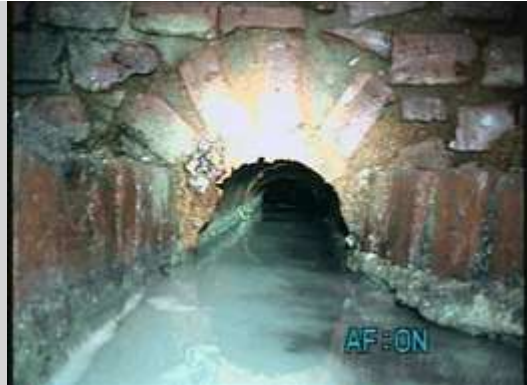
12 O'Clock Outflow

8 in. Circular Gravity Sewer  
Pipe Out @ 12 O'Clock

Pipe Material: **Clay** ☐ Pipe Lined

Invert Depth: **10.40** (ft.) Flow Characteristics: **Slow**

Infiltration: **None** Pipe Seal Cond: **Unknown**

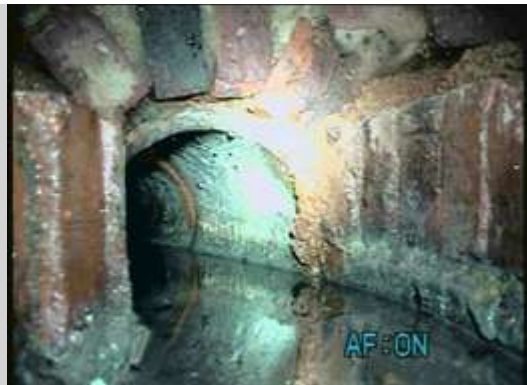
3 O'Clock Inflow

10 in. Circular Gravity Sewer  
Pipe In @ 3 O'Clock

Pipe Material: **Clay** ☐ Pipe Lined

Invert Depth: **10.30** (ft.) Flow Characteristics: **Slow**

Infiltration: **None** Pipe Seal Cond: **Unknown**

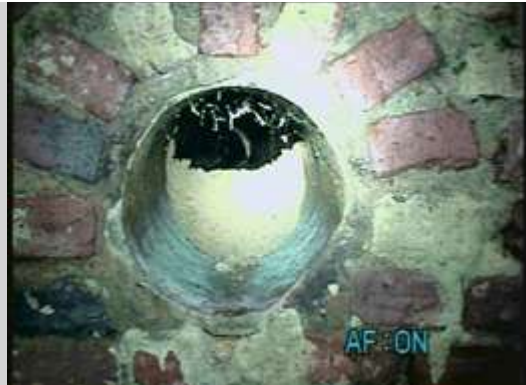
6 O'Clock Inflow

8 in. Circular Gravity Sewer

Pipe In @ 6 OClock

Pipe Material: **Clay** ☐ Pipe Lined

Invert Depth: **8.66** (ft.) Flow Characteristics: **Fast**

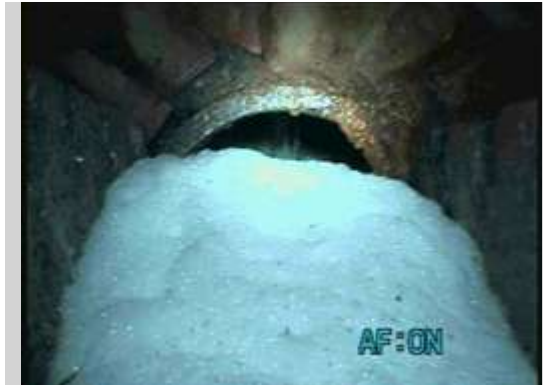
Drop In @ 6 OClock

Drop: **Outside** Direct

Inv Depth: **10.20** (ft.)

Drop Condition: **Open**
